**Insurance  
Institute for  
Business &  
Home  
Safety®**

# **ATTACHED STRUCTURES HIGH WIND RESEARCH**

**JULY 2014**

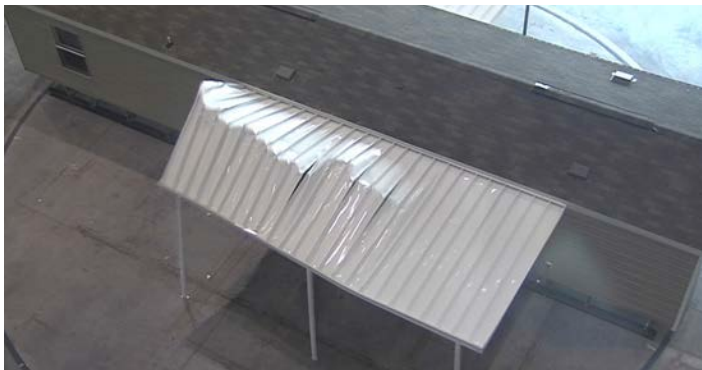
Figure 4. Buckling of pans at mid-span.

Most of the roofs observed in the survey of manufactured home parks were fabricated with thin metal pans about 12" wide with vertical ribs along the edges that snap together, overlap or are clamped together. These panels are typically referred to as "pans." Old pans typically had structural vertical edge ribs that were 1-3/4" tall while new ones typically have 3" tall ribs. Contractors with a long history of carport construction have indicated that 19 thousandths (0.019") thick and 24 thousandths (0.024") thick pans were common on older carport roofs while most manufacturers currently only supply thicker pans that are at least 32 thousandths (0.032") thick. During strong winds, these thin metal pans can buckle as shown in Figure 4 (page 6). For older thin metal pans, buckling may be one of the weakest links. Pans made of 0.024" thick aluminum that spanned from the wall of the home to an eave 12' away (a very common configuration for older carports) buckled when subjected to wind gusts equivalent to building code-defined Exposure B wind gusts of about 70 mph. Thicker 0.032" thick aluminum pans with the same span buckled when subjected to wind gusts equivalent to Building Code-defined Exposure B wind gusts of about 105 mph, a 50% increase in wind speed and a 50% increase in strength.

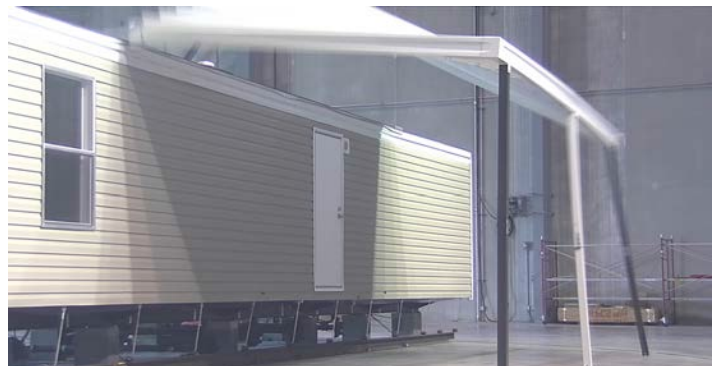
Figure 5. Separation of carport from home.

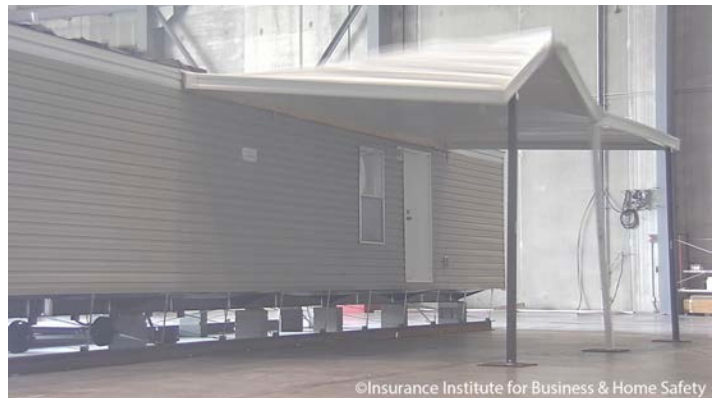
Figure 6. Buckling of beams supporting roof edge.

Beams and other members supporting the eave of the carport roof that are too small or weak for the span between posts also can buckle during a severe wind storm, which can lead to total destruction of the carport and subsequent damage to the home. This type of failure is illustrated in Figure 6 (page 7). The survey of older carports discovered a number of cases where eave beams were basically non-existent or considerably smaller than current engineering would suggest. Figure 16 (page 10) shows two examples. Figures 30 and 31 (page 15) show additional typical examples of weak eave beam supports used in older carports. Figure 30 shows a round beam that was used as the support beam near the edge of the carport roof, while Figure 31 shows use of a small channel. Typically the gutter attached to the edge of the pans provides little additional bending restraint because it is not supported by the posts and is often very thin metal. In addition, the gutter beam that buckled in Figure 6 at an Exposure C equivalent gust wind speed of 95 mph (Exposure B equivalent gust wind speed of 105 mph) had a span of 12'. Replacing the beam at the eave is not a particularly difficult or expensive proposition and should be considered when posts are being replaced. Where beams are replaced, roof pans should be screwed to them. In a couple of instances the survey of carports discovered cases where an additional beam was added at the eave.

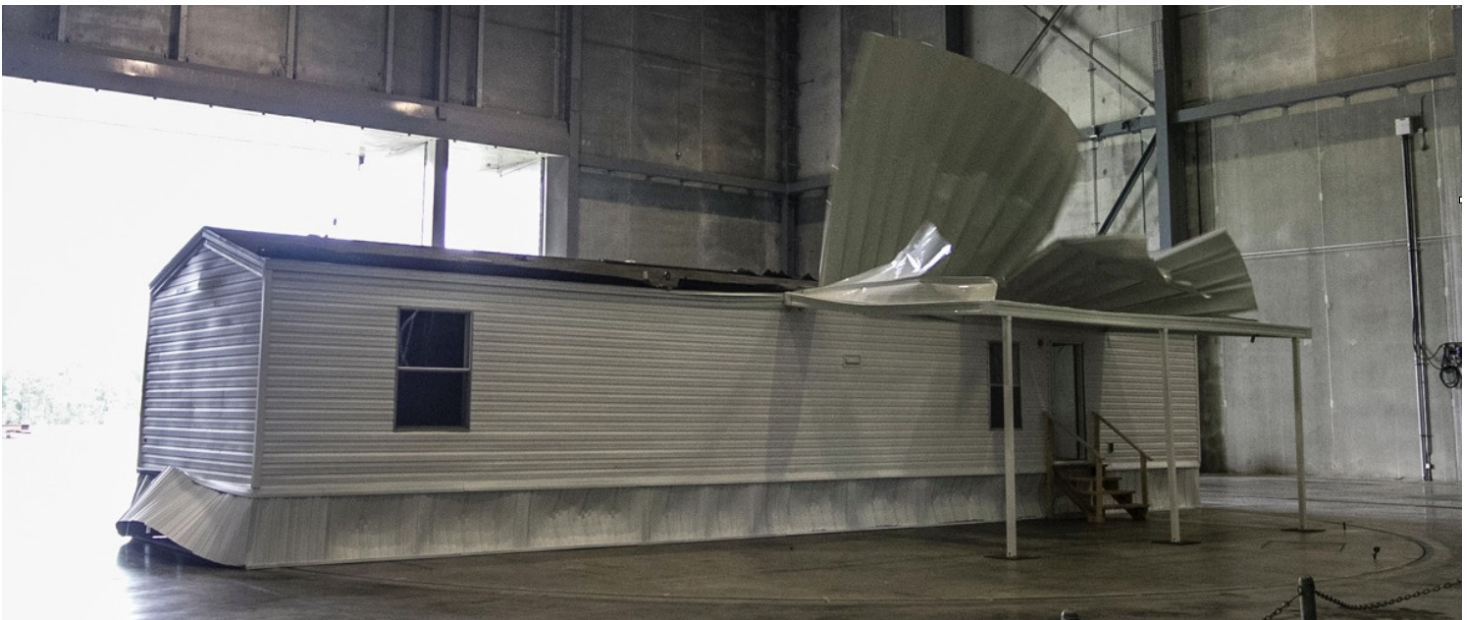
Figure 7. Failure of connections between roof pans and support beam at roof eave.

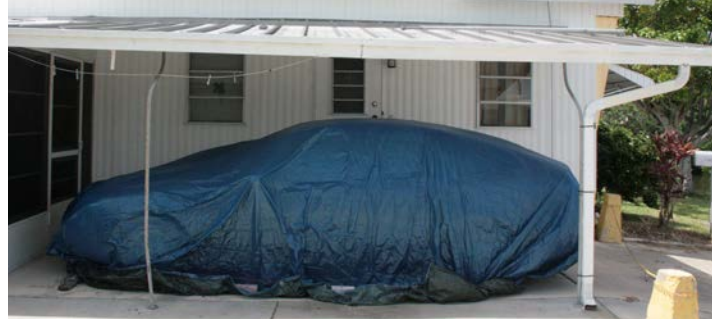
Figure 9. Weak bent post; note sagging roof.

In order to resist these kinds of uplift forces, the posts need to be straight and undamaged. Posts should be checked to see if there is bending or cracking, possibly from vehicles hitting them. Have damaged post(s) repaired or replaced. Check to determine whether there is corrosion or rotting of posts at the foundation or whether connection hardware is rusted, missing or limited to small screws. Replace corroded or rotted posts and make sure that hardware anchoring posts are in good condition.

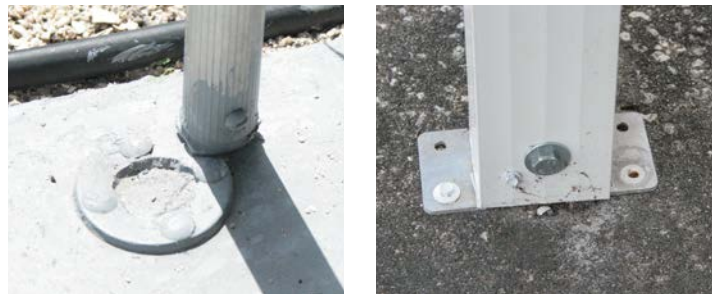
Figure 10. Posts with little or no connection to slab.

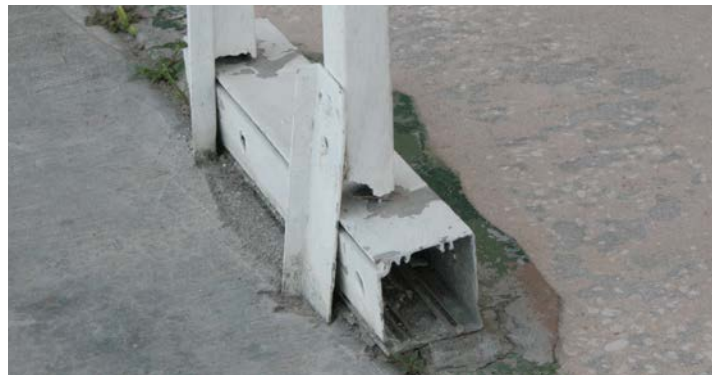
Figure 11. Damaged decorative support with weak repair attempt of connection/support at base.

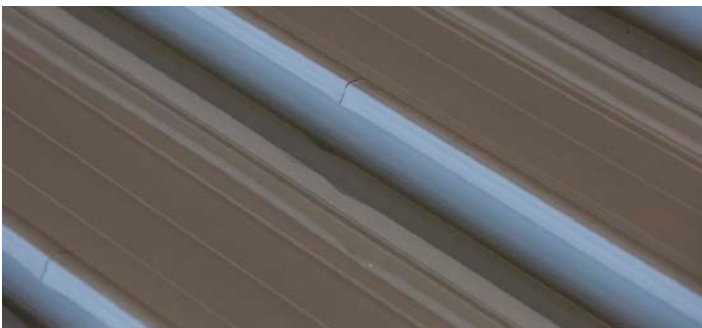
Figure 8. Cracking of roof pans caused by wind-induced vibration.

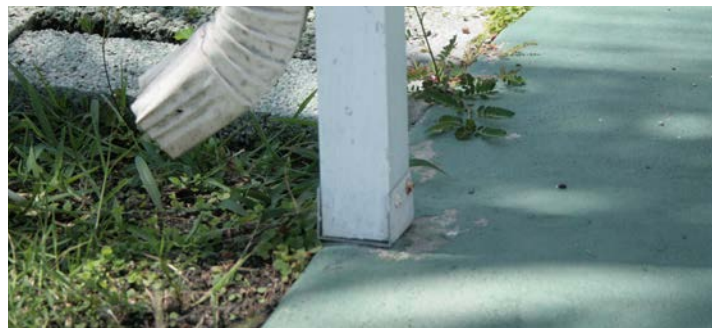
Figure 12. Thin sheet metal and small sheet metal screws are used to anchor post; anchor bolt is hidden under post and much too close to edge of concrete.

At the base of the post, check how close any anchor bolts are to an edge of the concrete. If they are less than 2.5" from the edge, work with a contractor to find a way to move these connections farther from the edge. Anchors too close to an edge can cause splitting of concrete when high winds try to lift up the carport.

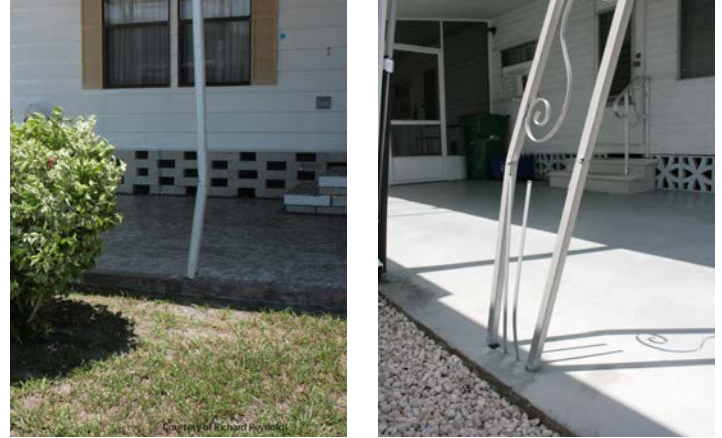
Figure 13. Cracked, fractured, and bent post.

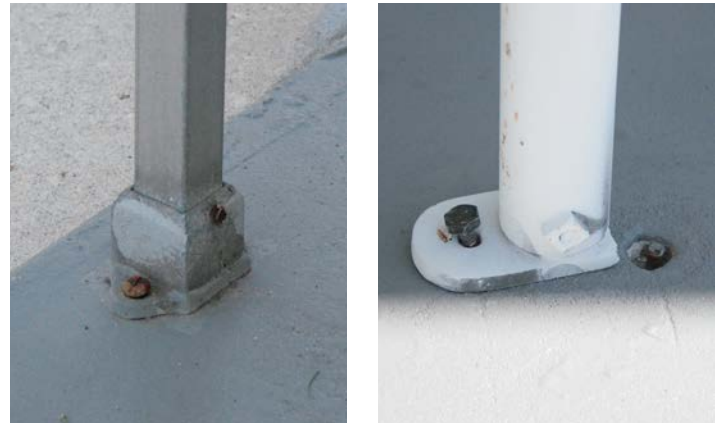
Figure 14. Other examples of poor post connections at base. Cast aluminum bracket (left) and broken bracket with dislodged screw (right). Note inadequate spacing of fasteners from each other.

may be exerted on them during a severe wind storm. If brackets are cast aluminum or aluminum sheet metal thinner than 1/8", it is worth replacing the brackets with plate type brackets that are at least 1/8" thick. A variety of commercially available brackets for anchoring the bottom of 3" posts to a concrete slab and the top to aluminum beams are shown in Figure 15.

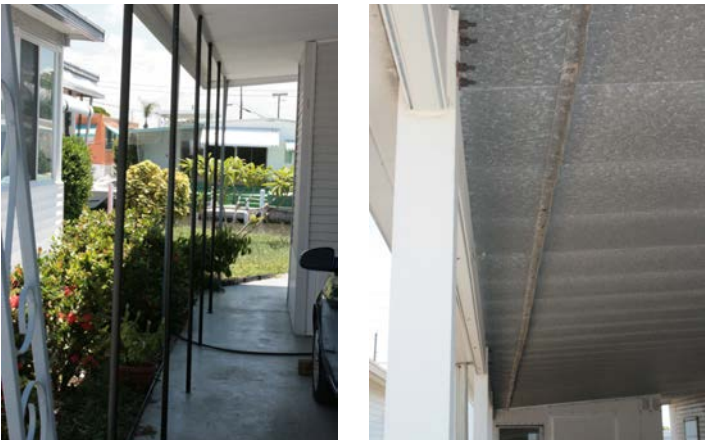
Figure 16. Left image shows typical old support system where pipe posts connect to small thin angle. Right image shows carport with replacement beam and 3" x 3" posts; note severely rusted bolts.

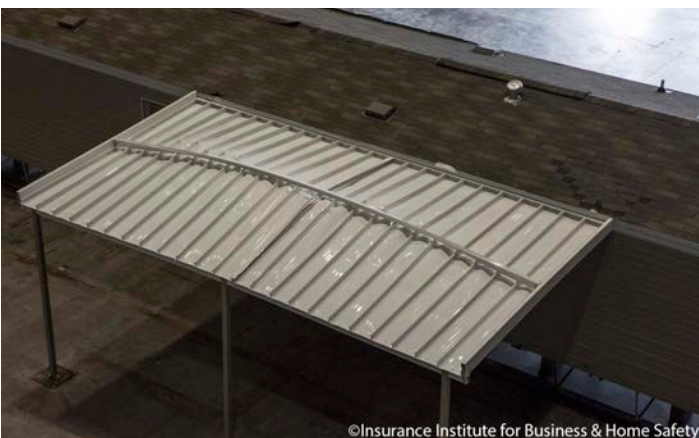
Figure 23. Roof buckled upward when subjected to 80-mph winds.

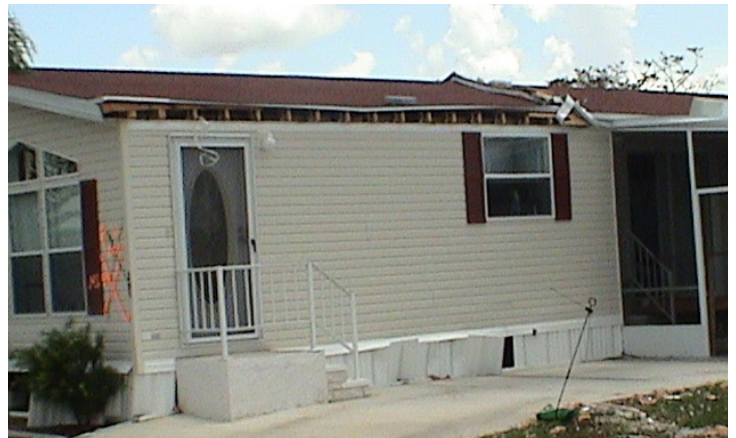
*Figure 27. (Above) Typical damage to the eave of a home when a carport roof is blown away during a hurricane. About six square feet of area at the top of the wall was opened allowing entry of wind-driven rain.*

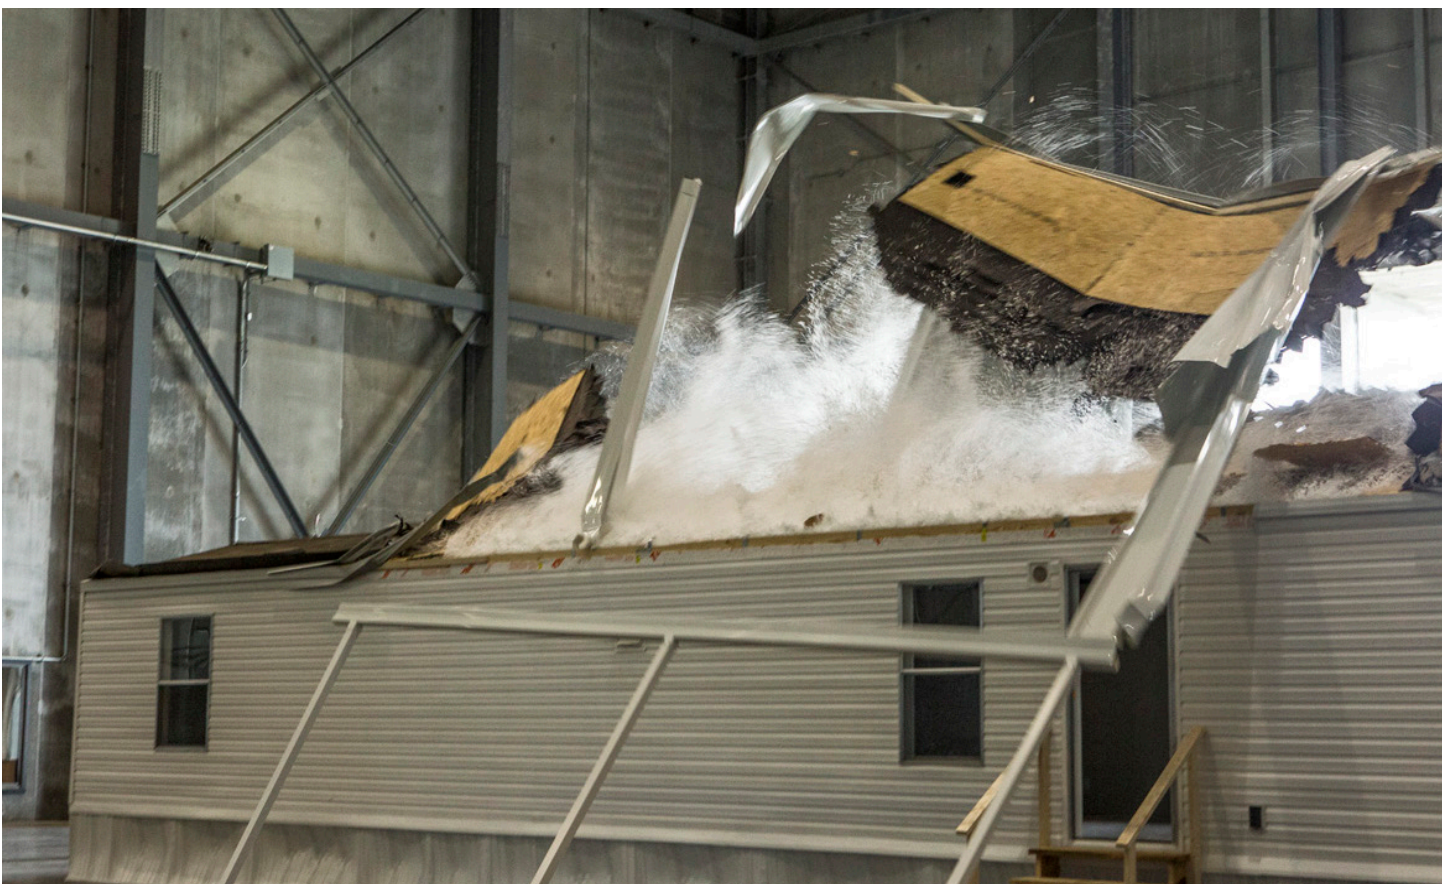
*Figure 28. Detaching carport pulled roof sheathing from a manufactured home, introducing blown insulation (white) into the airstream.*

When a carport roof detaches from a home it may well take some of the flashing, siding, structure, and possibly part of the roof with it. This damage to the home's exterior can allow tremendous amounts of wind-driven rain to enter the home, destroying finishes and contents. If structural damage occurs, it may lead to progressive damage and possibly collapse of walls or loss of more and more of the roof. Figure 5 (page 6) shows a weak carport connection failing. Figure 27 (page 14) shows typical eave and fascia/sub-fascia damage that occurred when a carport roof blew away during Hurricane Charley, which struck Florida in 2004. This left a hole in the home of about six square feet for rain to enter. Figure 28 (page 14) shows damage to a manufactured home that occurred when the roof of a carport blew off and took some of the roof sheathing with it.

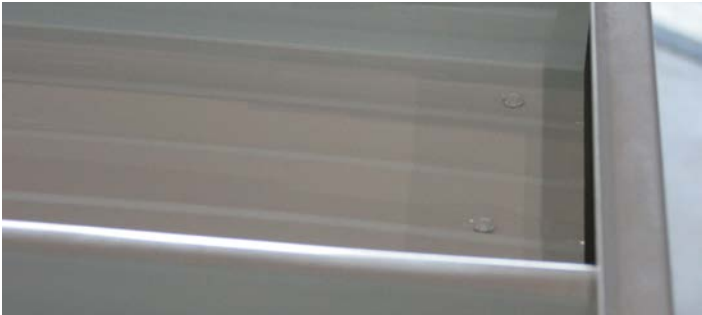
Figure 32. Attachment of roof pans to frame below using small screws with enlarged heads.

Many roof pans have been connected to the support beams by small sheet metal screws with an enlarged head. This produces a rigid connection and despite the enlarged head a relatively small clamping area for the thin aluminum pans (Figure 32). Initiation of the panel connection failure when such fasteners are used can be seen in Figure 33. Larger self-drilling TEK screws with composite metal/neoprene washers are readily available and provide a much better connection of the pans to the framing below them (Figure 34). The neoprene layer on the bottom of the washer helps spread out the clamping force and also helps keep water from leaking around the fastener. Because older fasteners may have caused some local corrosion (Figure 35) that would weaken the material around it, an easy retrofit is to simply add four larger TEK screw fasteners (typically #10 fasteners) with the combination metal/neoprene washers to anchor the bottoms of the pans to the framing below and just leave the existing fasteners.

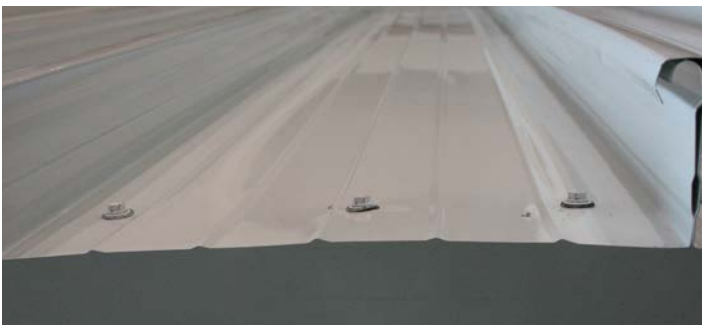
Figure 34. Initiation of panel connection failure at connections using small screws without metal/neoprene combination washers.

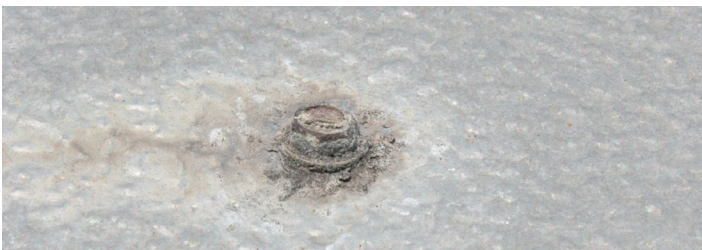
Figure 35. Corrosion around existing fastener without isolating neoprene layered washer.
