**Insurance  
Institute for  
Business &  
Home  
Safety®**

# **ATTACHED STRUCTURES HIGH WIND RESEARCH**

**JULY 2014**

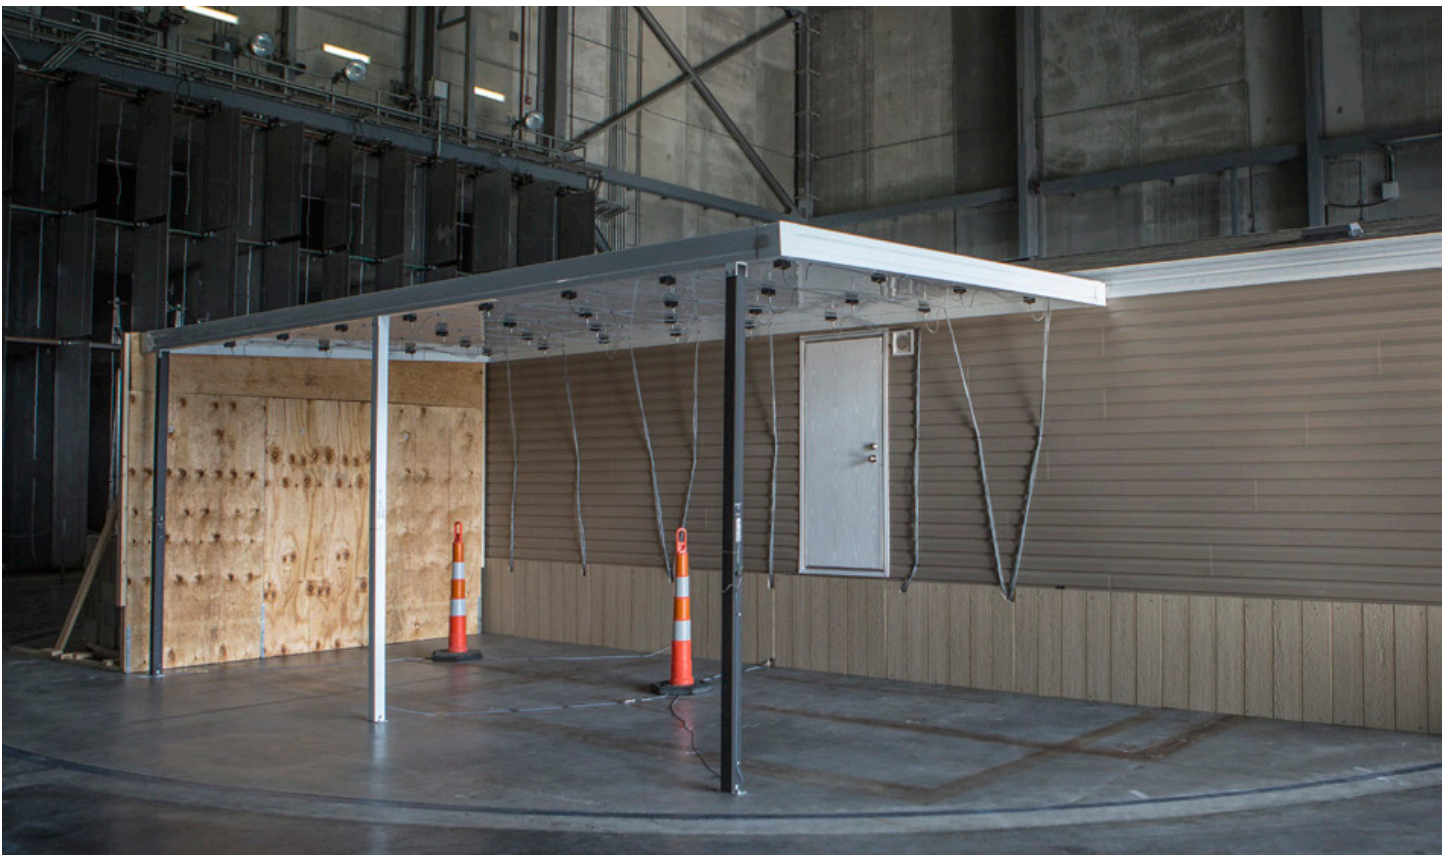
Figure 1. Instrumented carport with skirting and wall blocking wind exit at one end.

Another series of tests was conducted with one 12' end of the carport blocked to represent configurations where a storage shed or some other structure is installed at the end of the carport, which blocks the wind flow through that end (Figure 1, page 4). For this configuration, the highest average uplift wind loads occurred for a wind direction of 30 degrees off perpendicular to the carport eave (Figure 3, page 5). The global peak uplift coefficient obtained by integrating the peak instantaneous net uplift pressure coefficients over the entire carport roof was -1.15 for this configuration. Consequently, the uplift loads are higher for the blocked configuration as compared to the open configuration when it is subjected to the same wind speed.

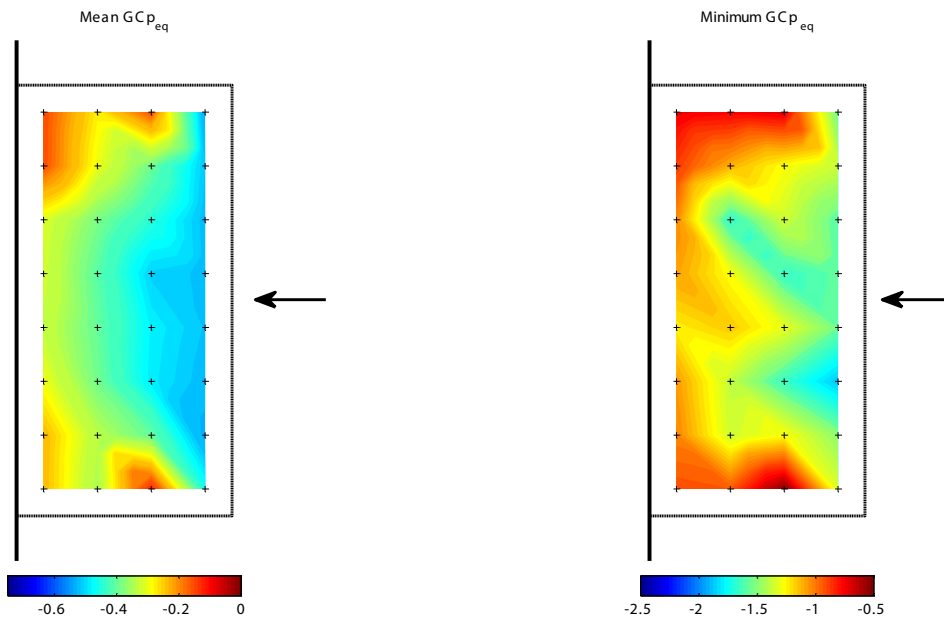
Figure 2. Distribution of mean (left) and minimum (right) wind pressure coefficients on carport roof with ends open and wind blowing perpendicular to the carport eave.

In one configuration, the 12' ends of the carport were open, as was the 24' side facing away from the manufactured home. As expected, the highest average wind uplift pressures occurred when winds were blowing directly toward the open 24' side of the carport with the home inhibiting the wind's exit (Figure 2, page 5). The global peak uplift coefficient obtained by integrating the peak instantaneous net uplift pressure coefficients over the entire carport roof was -0.82 for this configuration. This is very close to the average uplift pressure coefficient of -0.85 from ASCE 7-10 for an open roof with obstructed flow. Because the carport is 12' wide from the side of the home to the eave where the beam and posts support the eave, normal engineering design would assume that the tributary area for wind pressures acting on the eave beam and posts would be the 6' width of the carport roof closest to the eave.

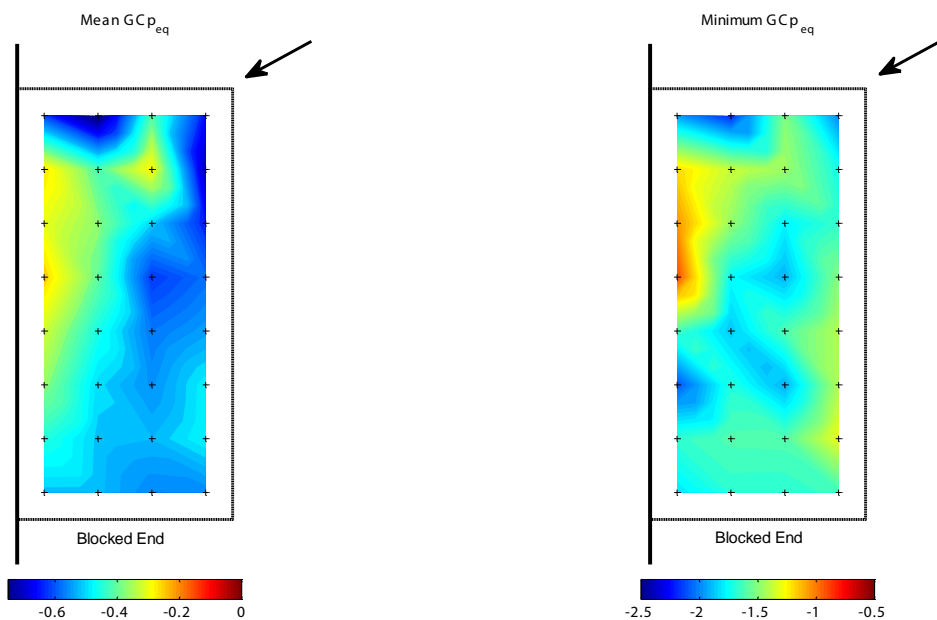
Figure 3. Distribution of mean (left) and minimum (right) wind pressure coefficients on carport roof with one end blocked and winds blowing 30 degrees off perpendicular to the carport eave.

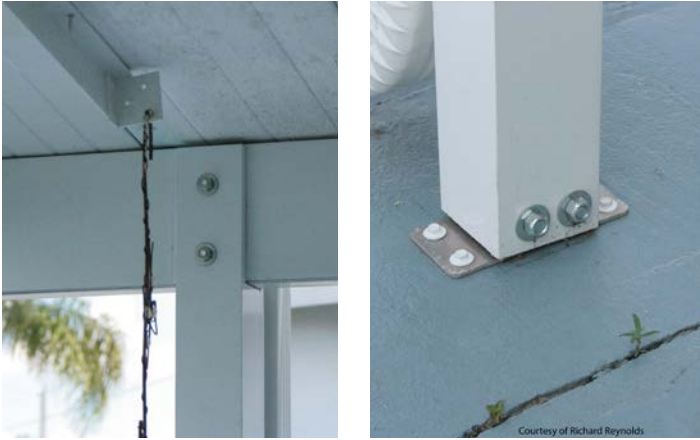
Figure 17. New beam and posts with improved connections supporting old roof.

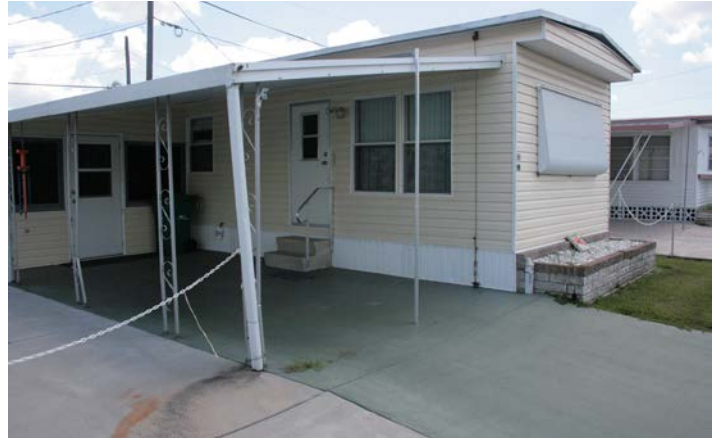
The survey of carports in manufactured home parks in Florida indicated there is some level of understanding that the thin pan roofs are susceptible to buckling upward in high winds. A number of carports included an angle attached to the top of the roof at mid-span between the wall of the house and the eave. The angle is anchored at the open end of the carport with a post that can be deployed when a storm threatens or when leaving during hurricane season. Two examples are shown in Figures 19 and 20. A more robust truss brace is shown in Figure 21a and was connected to a beam under the edge of the carport roof. Another complicated top-mounted bracing system is shown in Figure 21b (page 13).

Figure 19. Angle attached to carport roof with temporary anchor post in place.

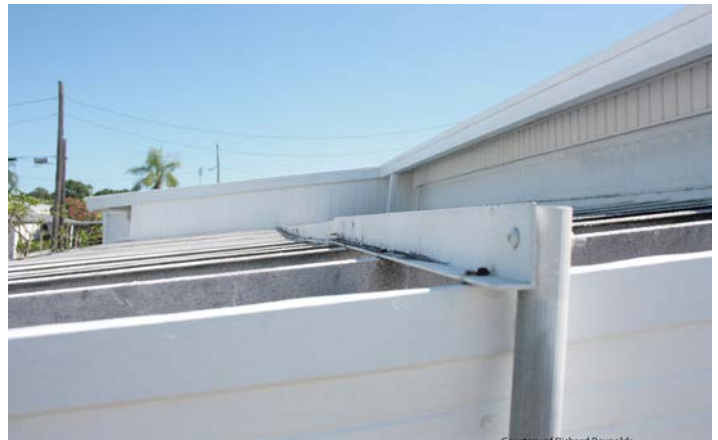
Figure 20. Close-up of angle and anchor post connection. Usually only the end of the angle is connected to a post.

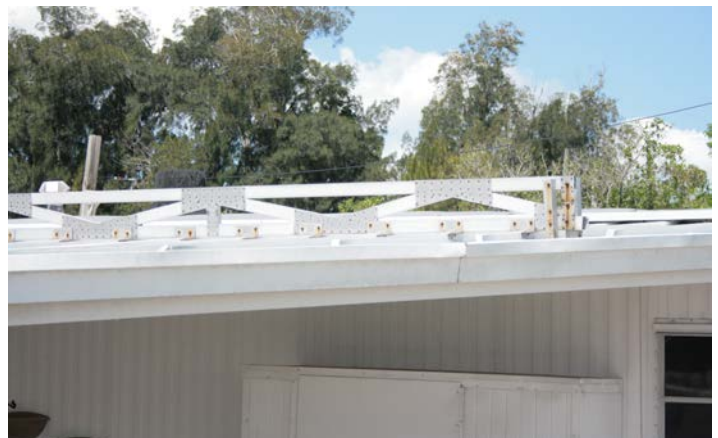
Figure 21a. Truss installed along middle of carport roof to brace pans.

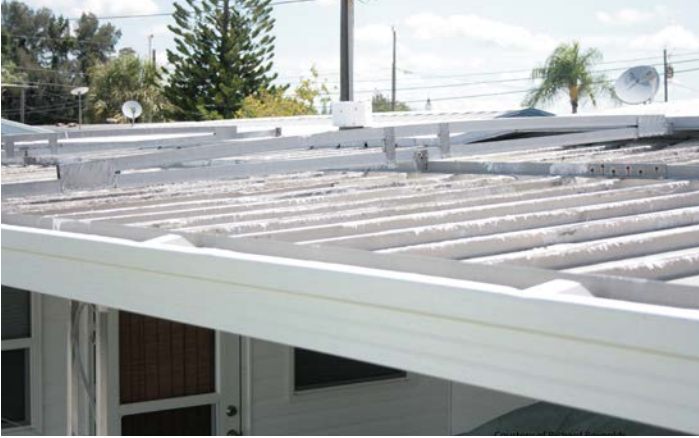
Figure 21b. Complex arch truss and brace system intended to prevent uplift buckling of roof pans.

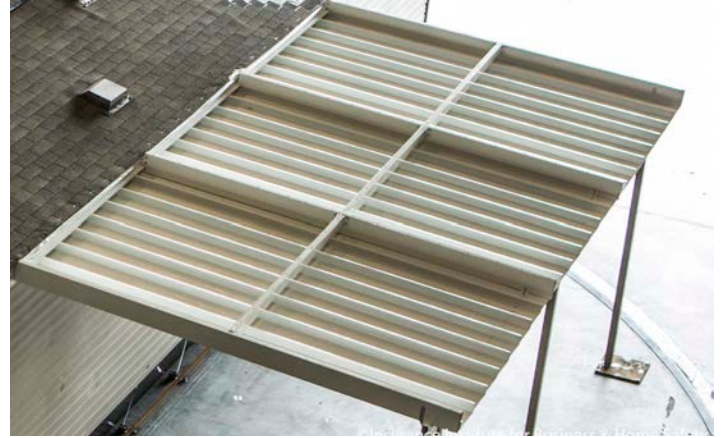
The second retrofit added two additional 2" x 7" beams running perpendicular to the home, as shown in Figure 24 (page 13), so that each section of 2" x 4" beam that ran along the middle of the carport roof only had to span 8'. This retrofit was tested with both 0.024" thick steel and aluminum pans without failure of either when subjected to wind in excess of 100 mph. Based on previous tests, failure would have occurred at lower wind speeds (about 70 mph for the aluminum pans) if these beams had not been added. This type of above-the-roof retrofit is only effective against wind uplift loads and would not help resist water or snow loads. A support structure based on the AAF Guide built under the roof deck, which helps support both wind uplift and snow/water gravity loads, is shown in Figure 25 (page 13). Figure 26 (page 13) shows the AAF-based support frame while the roof pans were being added.

Figure 24. Modified retrofit with two additional 2" x 7" beams so each section of 2" x 4" brace only spanned 8'.

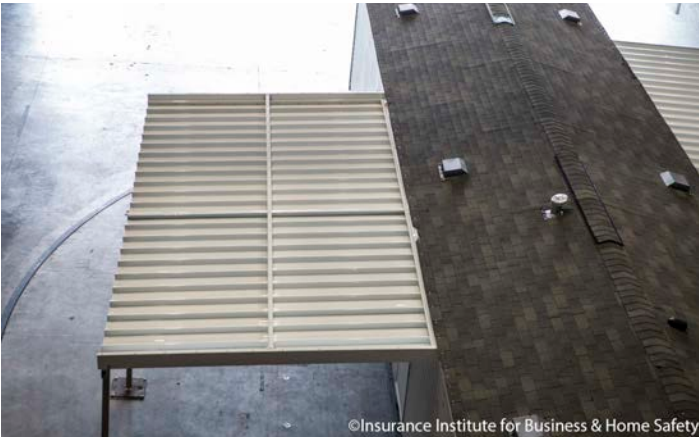
IBHS installed and tested two over-the-top bracing systems in an attempt to evaluate these approaches to retrofit/bracing concepts where an attempt is made to prevent buckling upward by holding down the middle of the roof pans. The first bracing system is shown in Figure 22 (page 13), using 0.024" pans. It consisted of two aluminum 2" x 7" beams at each end of the carport roof supporting a 2" x 4" beam, installed with the 4" dimension perpendicular to the roof, that spanned across the middle of the roof pans to restrain their upward deflection and buckling. The system buckled at an Exposure B equivalent gust wind speed of about 85 mph as shown in Figure 23 (page 13). That structure would have been completely destroyed if it had been subjected to higher winds or possibly winds of longer duration.

Figure 22. Single 2" x 4" beam across middle of pans to help resist uplift; 2" x 4" beam is supported at ends by 2" x 7" beams spanning ends of carport.

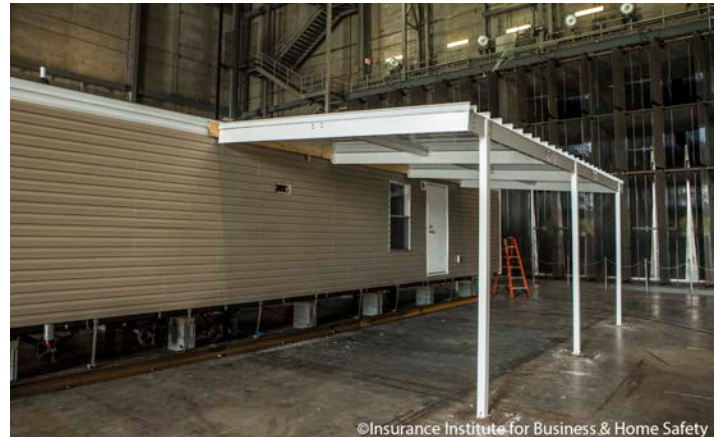
Figure 25. Photo of AAF-based design that withstood wind speeds in excess of 100 mph with no damage. Tests were conducted with both 0.024" and 0.032" thick pans, which were attached to beam between wall and eave using screws with metal/neoprene washers.

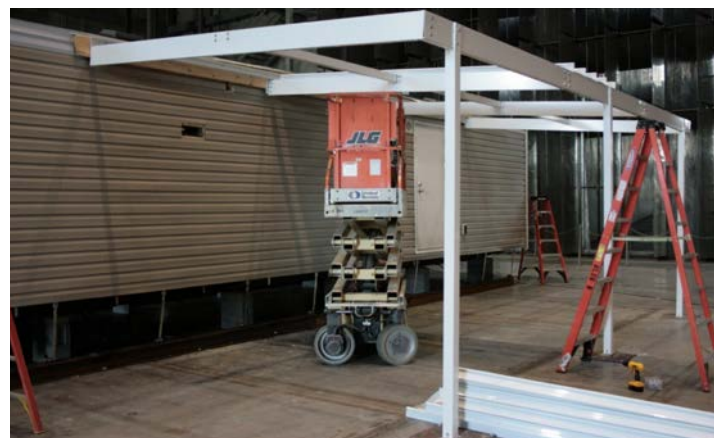
Figure 26. Frame used to support roof pans in AAF-based design.

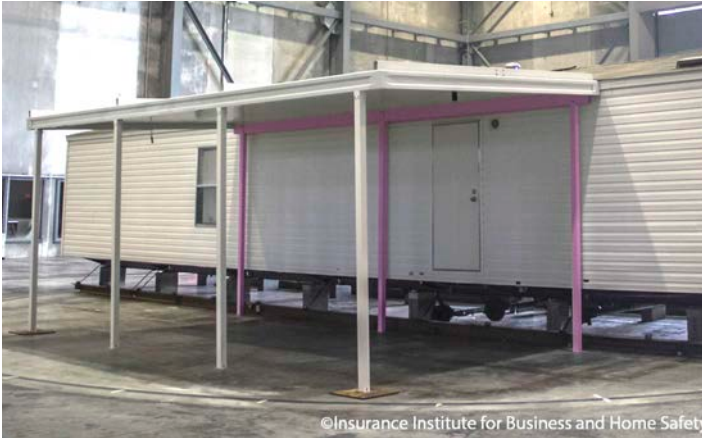
Figure 29. Carport with 4th wall located next to the home. The 4th wall is highlighted in pink.

The final wind tests of carports conducted at IBHS started with two identical carports attached to opposite sides of a manufactured home. One of the carports was retrofitted to improve its wind resistance. The retrofits included the installation of a fourth wall to resist the wind uplift loads on the edge of the carport next to the home as shown in Figure 29. The connection of the carport roof to the side of the home was not altered. Sideways wind forces on the carport roof are much smaller than the wind uplift forces, and these sideways forces can be easily resisted by the connection to the home. The fourth wall was specifically added to keep the roof from lifting up and detaching from the side of the manufactured home.

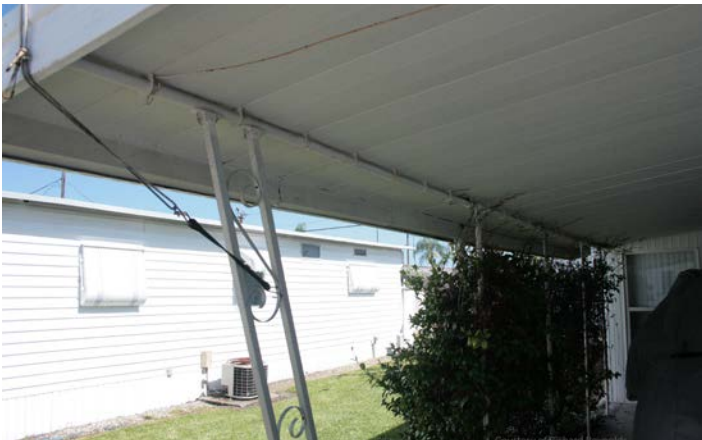
Figure 30. Use of a round beam to provide beam support at eave of carport.

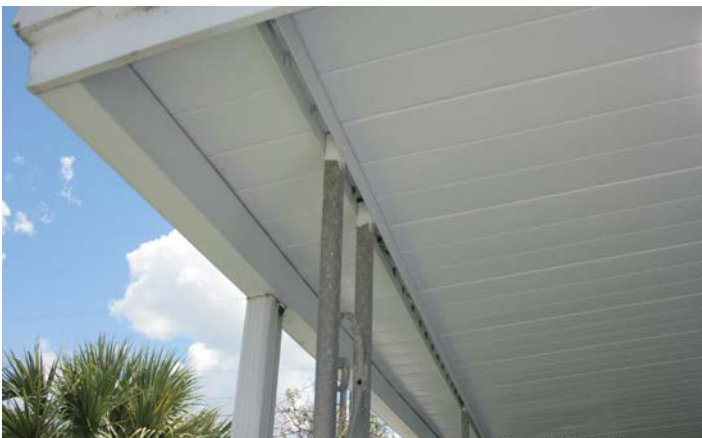
Figure 31. Use of a thin sheet metal-like channel to provide beam support at eave of carport.

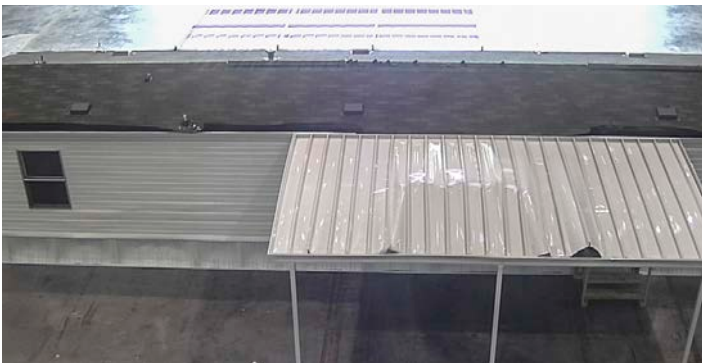
Figure 33. Attachment of roof pans to frame below using #10 TEK screws with combination metal/neoprene washers.

Many roof pans have been connected to the support beams by small sheet metal screws with an enlarged head. This produces a rigid connection and despite the enlarged head a relatively small clamping area for the thin aluminum pans (Figure 32). Initiation of the panel connection failure when such fasteners are used can be seen in Figure 33. Larger self-drilling TEK screws with composite metal/neoprene washers are readily available and provide a much better connection of the pans to the framing below them (Figure 34). The neoprene layer on the bottom of the washer helps spread out the clamping force and also helps keep water from leaking around the fastener. Because older fasteners may have caused some local corrosion (Figure 35) that would weaken the material around it, an easy retrofit is to simply add four larger TEK screw fasteners (typically #10 fasteners) with the combination metal/neoprene washers to anchor the bottoms of the pans to the framing below and just leave the existing fasteners.
